Report No. CG-D-50-77

ESTIMATE OF THE POTENTIAL BENEFIT
OF THE PRESSURE RELIEF VENT/FLAME
DEFLECTOR CONCEPT
USING IN-DEPTH ACCIDENT INVESTIGATION

FINAL REPORT

Prepared for
U. S. DEPARTMENT OF TRANSPORTATION
UNITED STATES COAST GUARD
Office of Research and Development
Washington, D.C. 20590

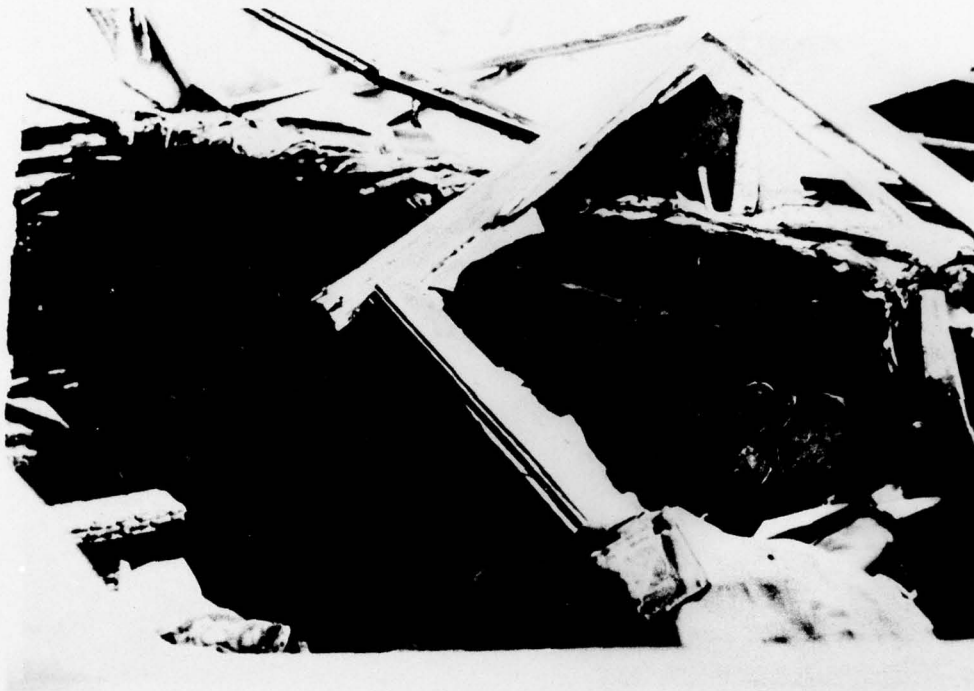
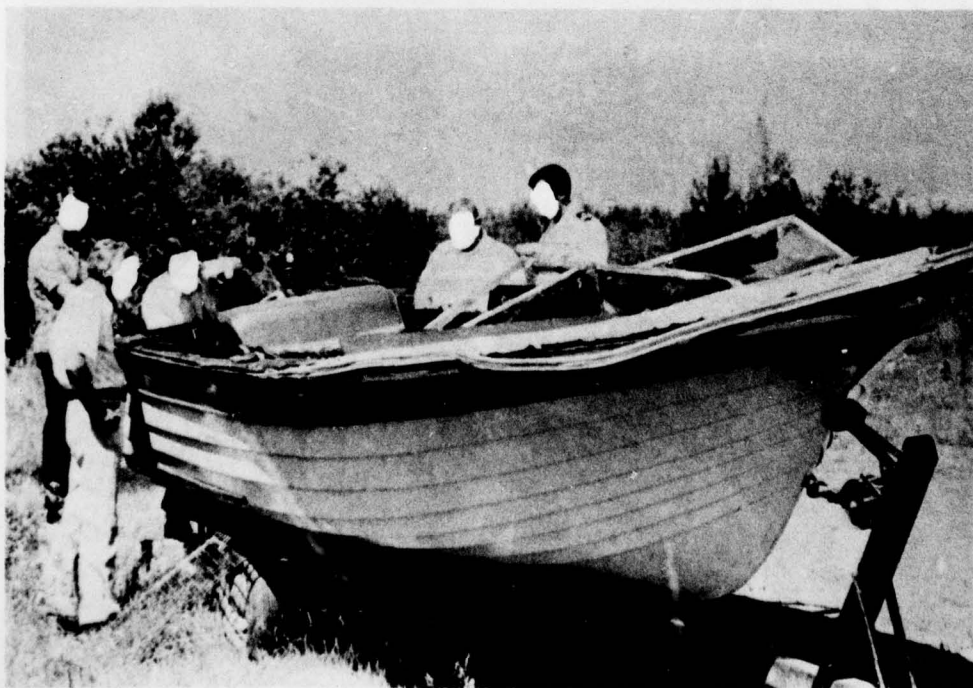
The interior of the boat was completely gutted by the fire, except for the bow section, as shown in Photographs 3 through 10. The fuel tank was permanently installed in the approximate center of the bow section. The fuel filler hose ran from the top end of the tank approximately 18 in. (45.72 cm) up to a 45 degree angle to the filler cap located on the bow top, port side. The vent line ran from the top of the tank (opposite end to filler hose) to the starboard side vent fitting. A copper fuel supply line ran from the tank top along the port side, under the forward section of the engine to a flexible hose connection on the starboard side. A flexible hose connected the supply line to the fuel pump and a flexible line had connected the fuel pump to the

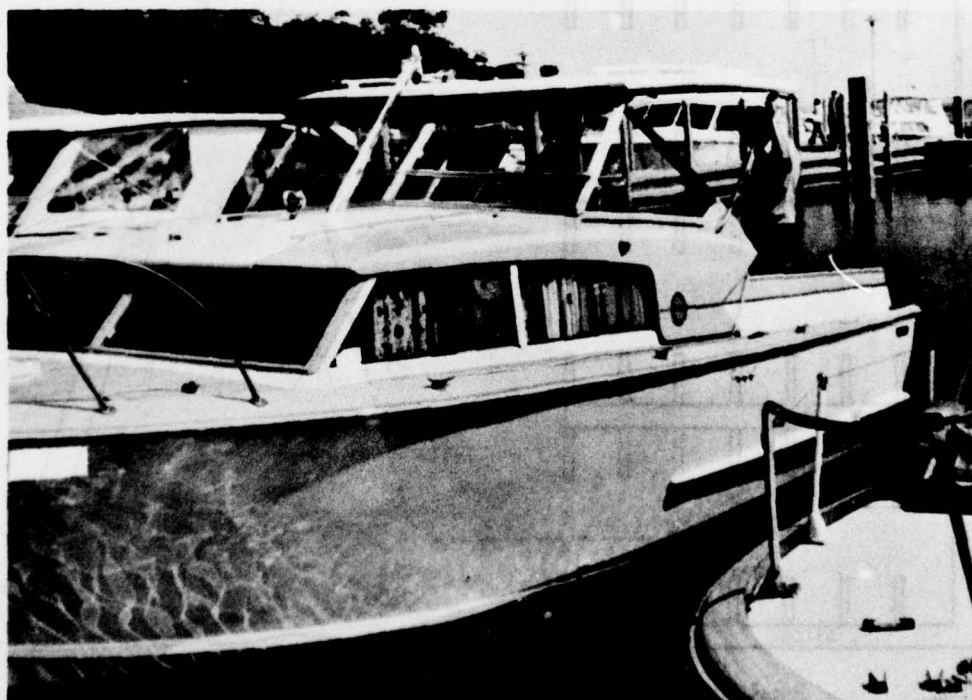
The interior of the boat was completely gutted by fire as shown in Photographs 1-7. The fuel tank was installed below deck on the longitudinal centerline approximately one foot forward of the engine compartment. The fuel filler hose ran from the top aft end of the tank down alongside the engine on the port side, then up at approximately a 45 degree angle to the filler cap located on top of the transom, port side. The vent line was routed with the filler hose from the tank around the engine to the vent fitting located on top of the transom, port side (see Figure 3). A flexible feed line ran from the tank top down to the fuel pump located at the bottom front port side of the engine. A rigid steel tube ran from the fuel pump output to the carburetor. Only charred pieces of the flexible lines in the engine compartment were found. According to the owner, no modifications had been performed on the boat, and with the exception of a new battery installed by the owner three months prior to the accident, no components had been repaired or changed. See Photographs 8-11 for undamaged boat similar in interior configuration.

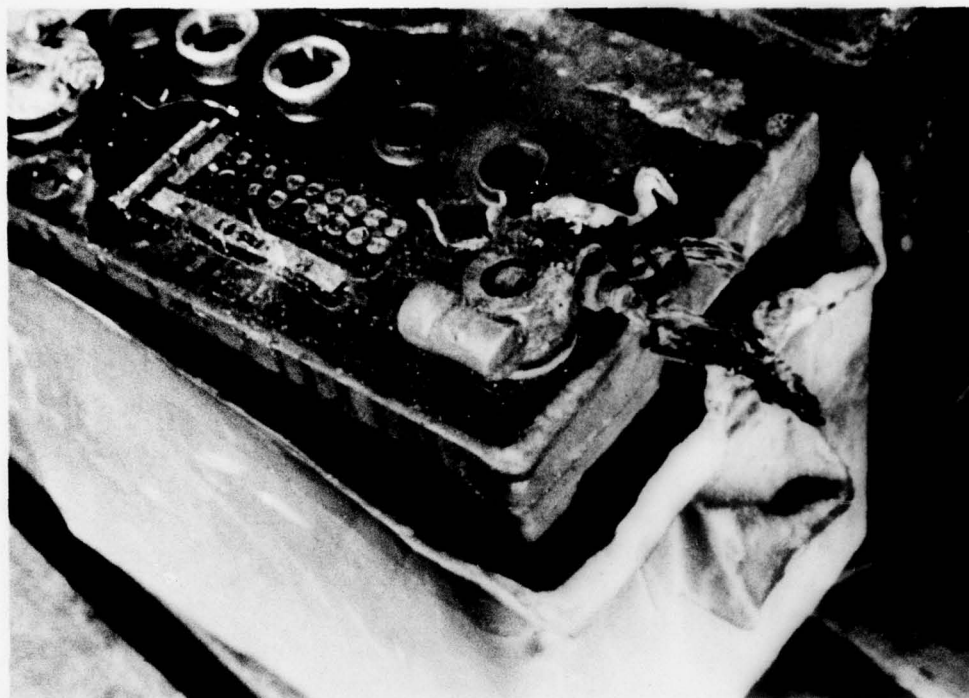
After the fire was extinguished, a local parish sheriff went aboard and cut the electrical wiring connected to the battery to prevent any electrical shorting. See Photographs 4 and 5.

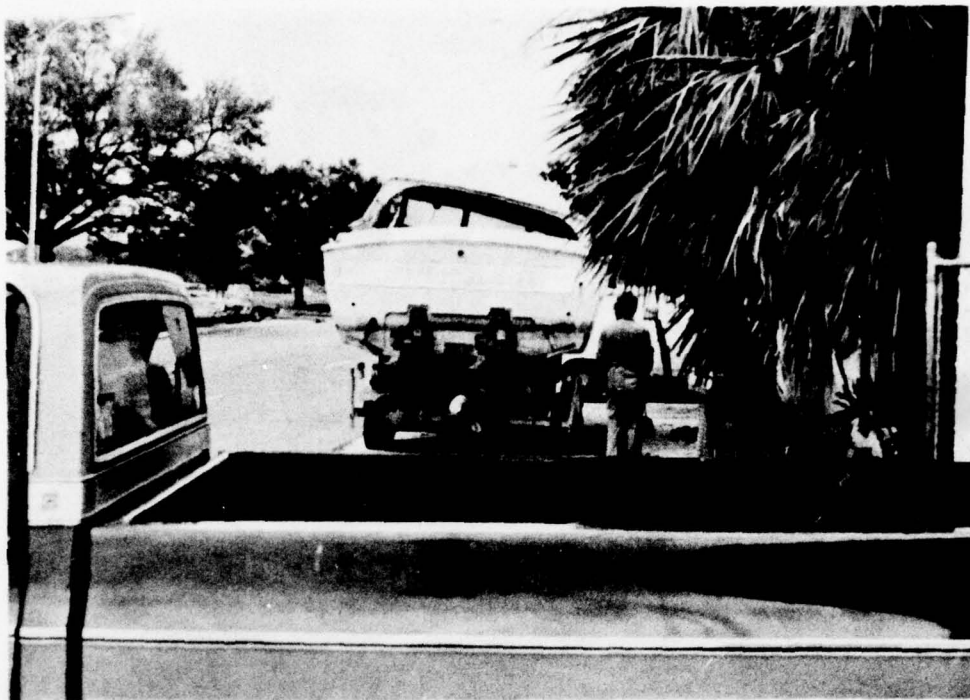
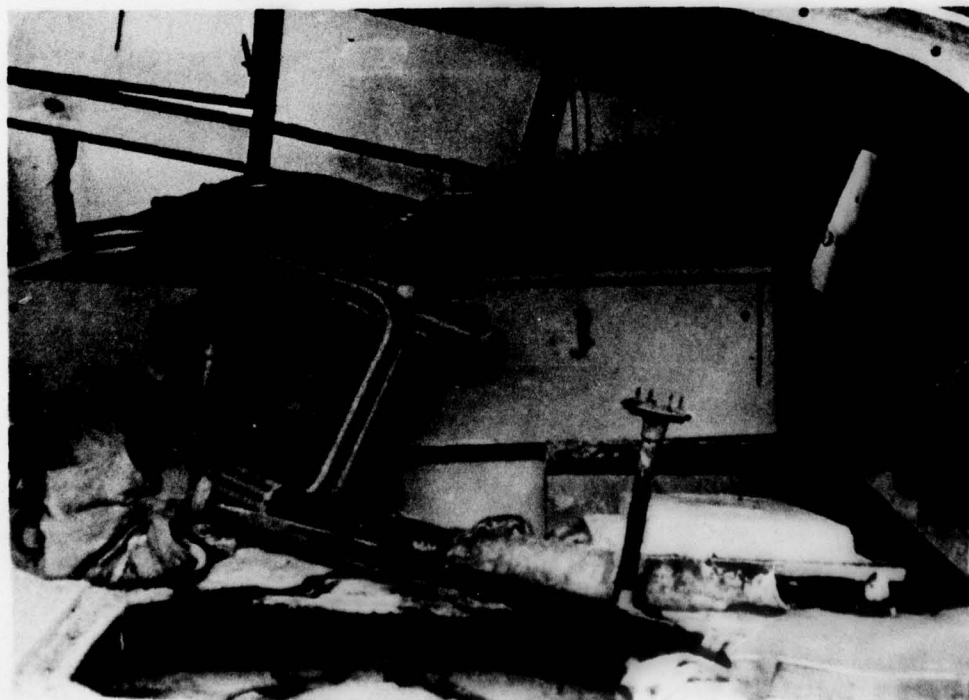
It was evident from the visual examination that the explosion was of high intensity and the combustion area probably covered the entire bilge. The deck was cracked or torn loose from the hull side around the entire boat. Permanently installed items such as storage cabinets, table, seats, etc. were torn loose from the deck and scattered around the interior. The cabin top had been torn loose from the sides and the starboard side had dropped down inside the passenger compartment. The fire damage was minor compared to the destruction caused by the force of the explosion. The engines appeared to be in reasonably good condition. ~~No evidence of fuel leakage could be found on any of the fuel lines or fittings.~~ The 150 gallon fuel tank was located on the boat centerline approximately four feet forward of the engines. The tank was full of fuel and no leaks were found. The electrical insulation on the wiring in the bilge area was badly burned. Some of the insulation damage could have been caused by electrical shorts which probably occurred after the explosion. Two small blowers were installed in the bilge, one in the engine compartment on the starboard side and one forward of the fuel tank. A fuel vapor detector sensor was installed in the bilge near the aft starboard corner of the fuel tank. The sensor was badly charred and one corner was missing. Post accident boat interior and exterior are shown in Photographs 9 through 19. Refer to Photographs 20 and 21 for engine hatch covers.

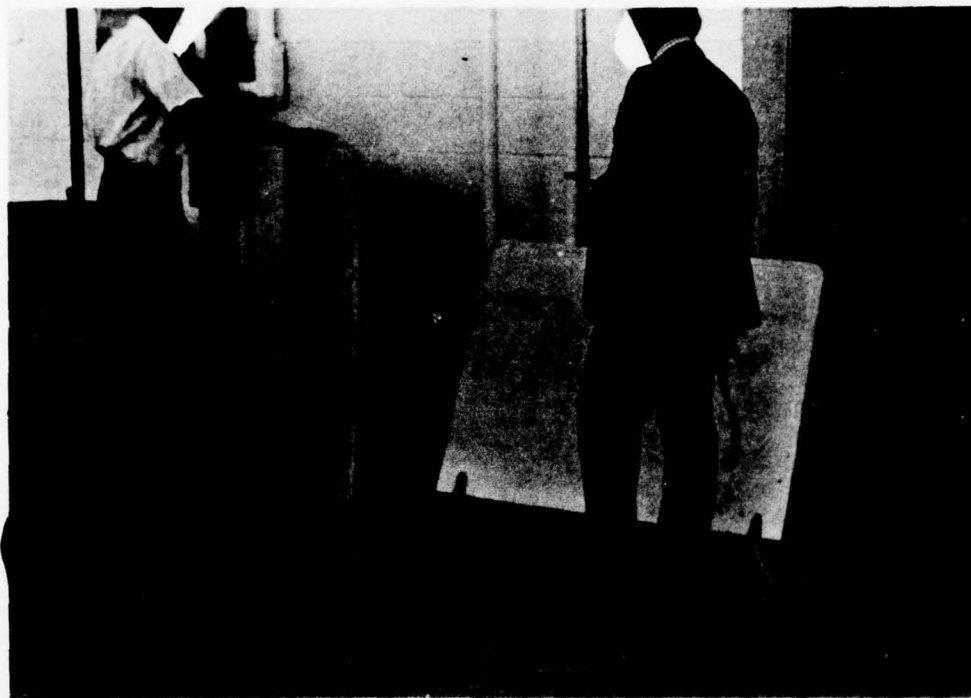
The explosion blew the engine hatch covers out of the boat exposing the bilge to the atmosphere which provided oxygen to sustain the fire. Immediately after the explosion, the entire bilge was on fire, which indicates that a considerable amount of raw fuel was in the bilge at this time. The fire was extinguished before the boat structure sustained any major fire damage. Plastic components and electrical wiring in the bilge did sustain severe damage as a result of the fire. Also, see discussion in Section 3.2.

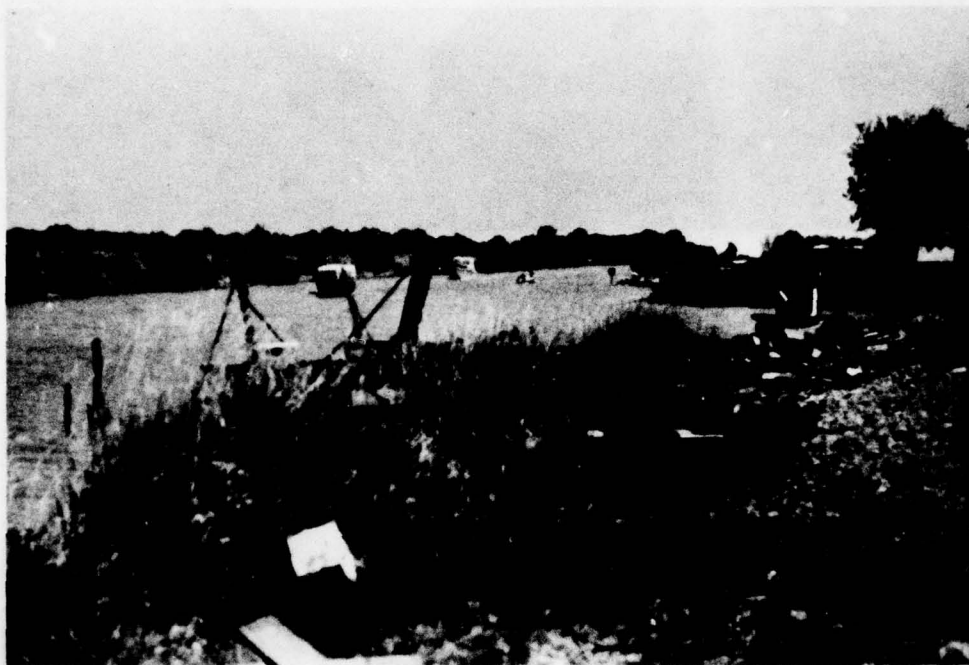
PHOTOGRAPH 1. ACCIDENT AREA

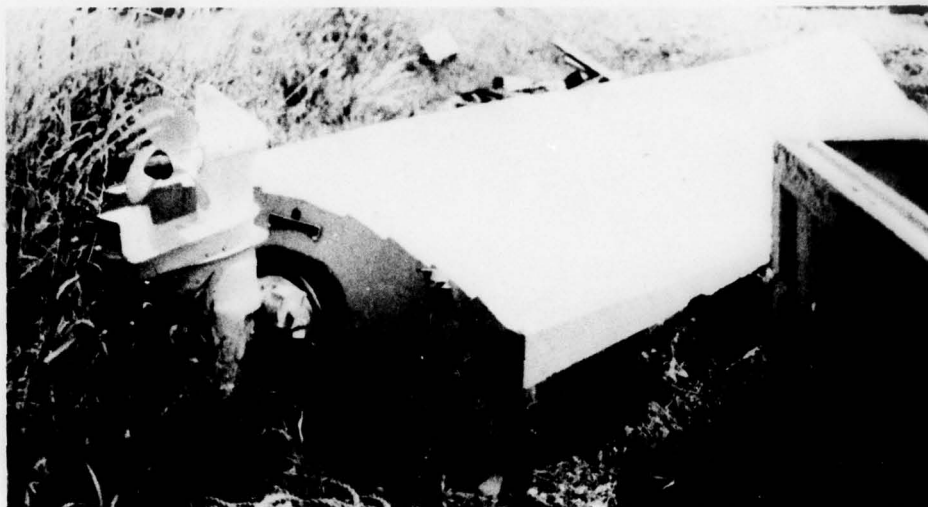
PHOTOGRAPH 2.

Refer to Photographs 2-4 for hull damage.

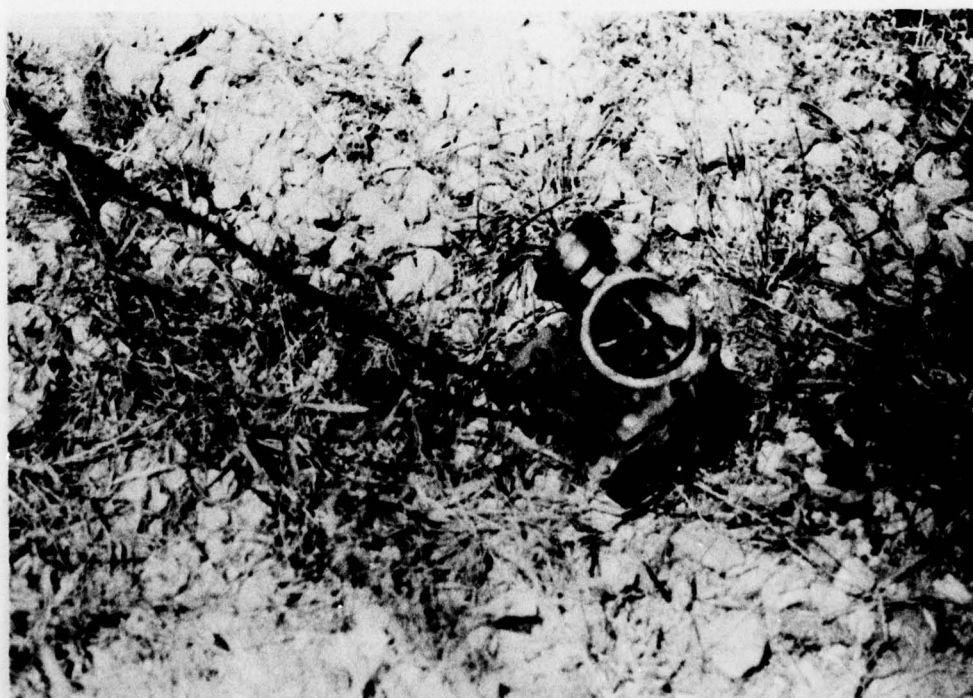
PHOTOGRAPH 8.

The fuel line between the fuel pump and carburetor was visually inspected. No breaks or ruptures were found in the line and the end fittings were tight. The output section of the fuel pump, including the threaded output hole, was melted by the fire. See Photographs 8, 9, and 10.
